# BUREAU OF SHIPS GROUP

## TECHNICAL INSPECTION REPORT

## WELDING

### OPERATION CROSSROADS

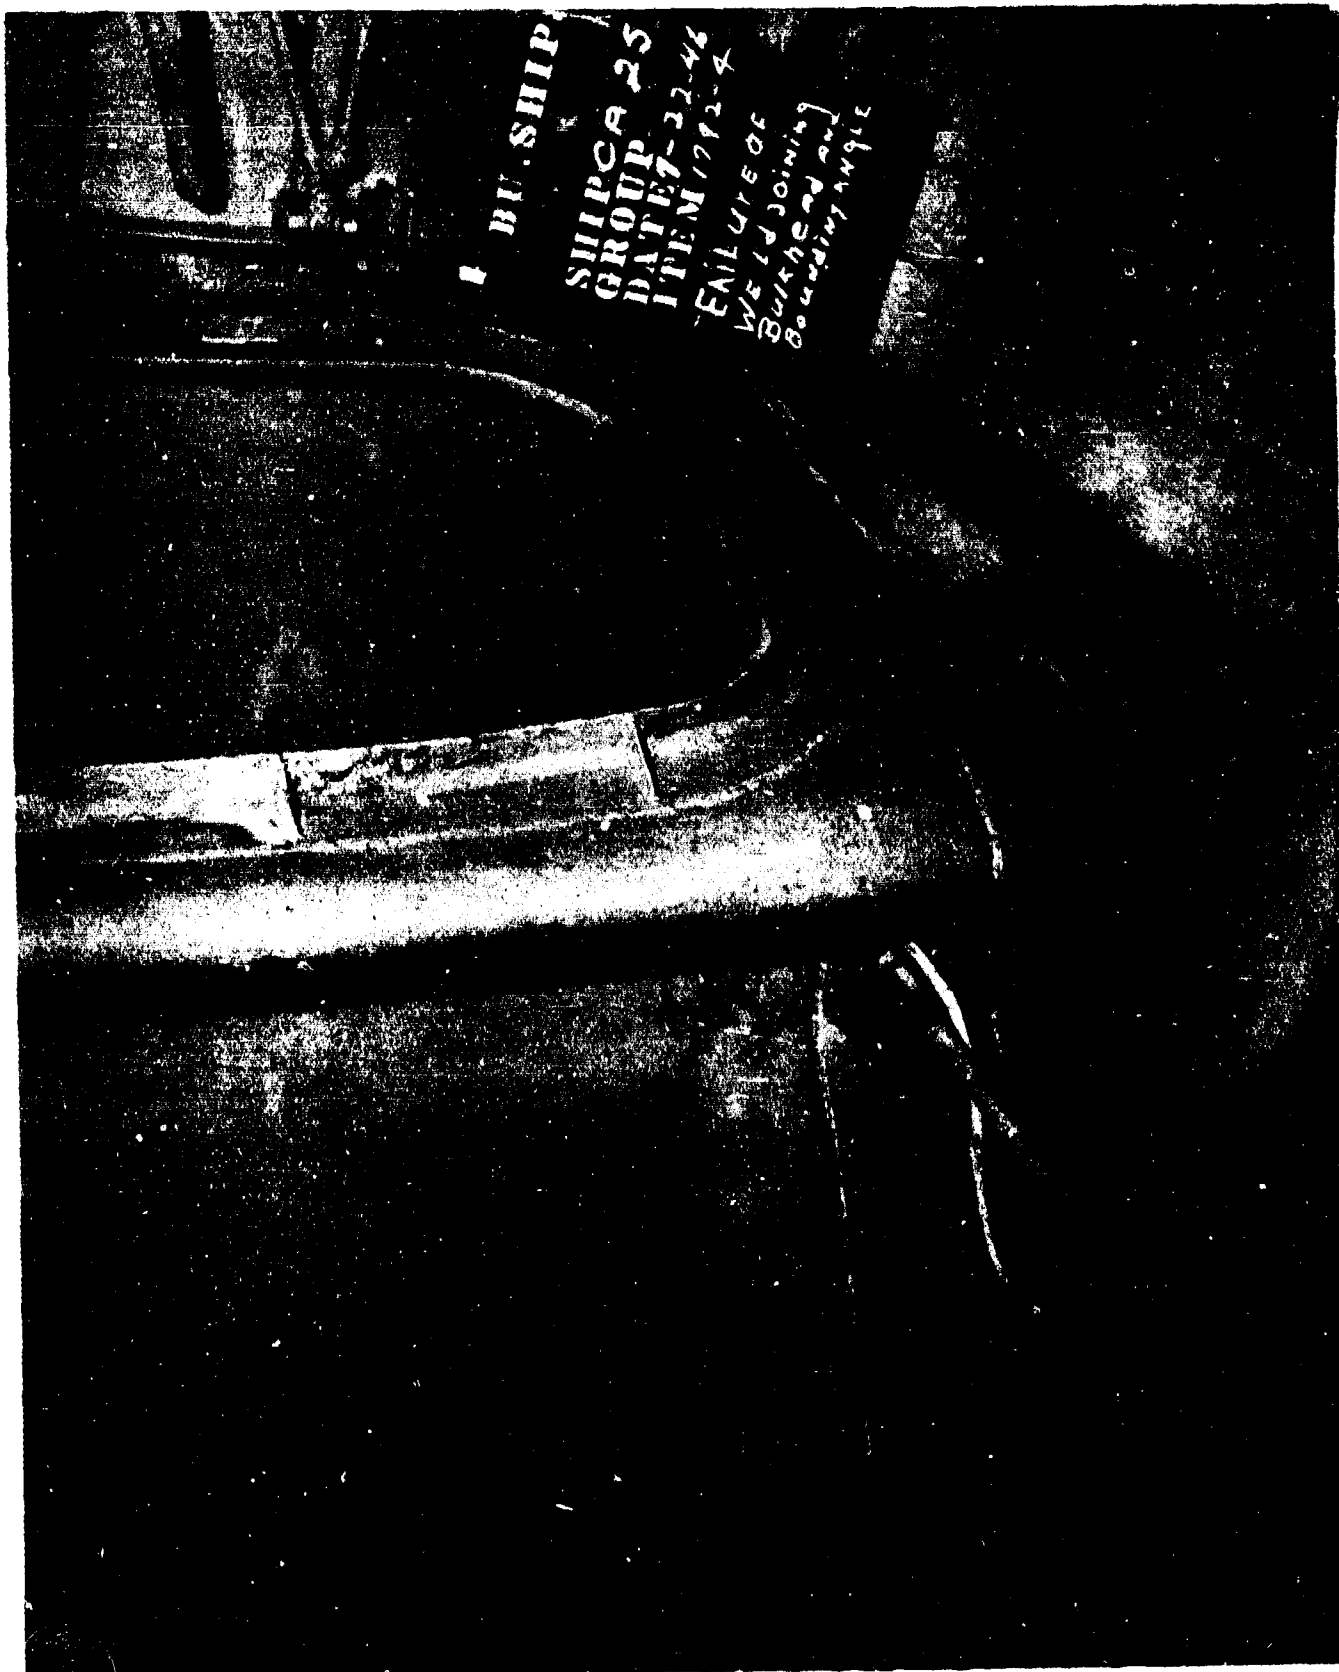
AA-CR-92-1782-4. USS SALT LAKE CITY (CA25). Failure of bulkhead bounding welds at main deck connection, port side, athwartship passage aft of wardroom, looking forward.

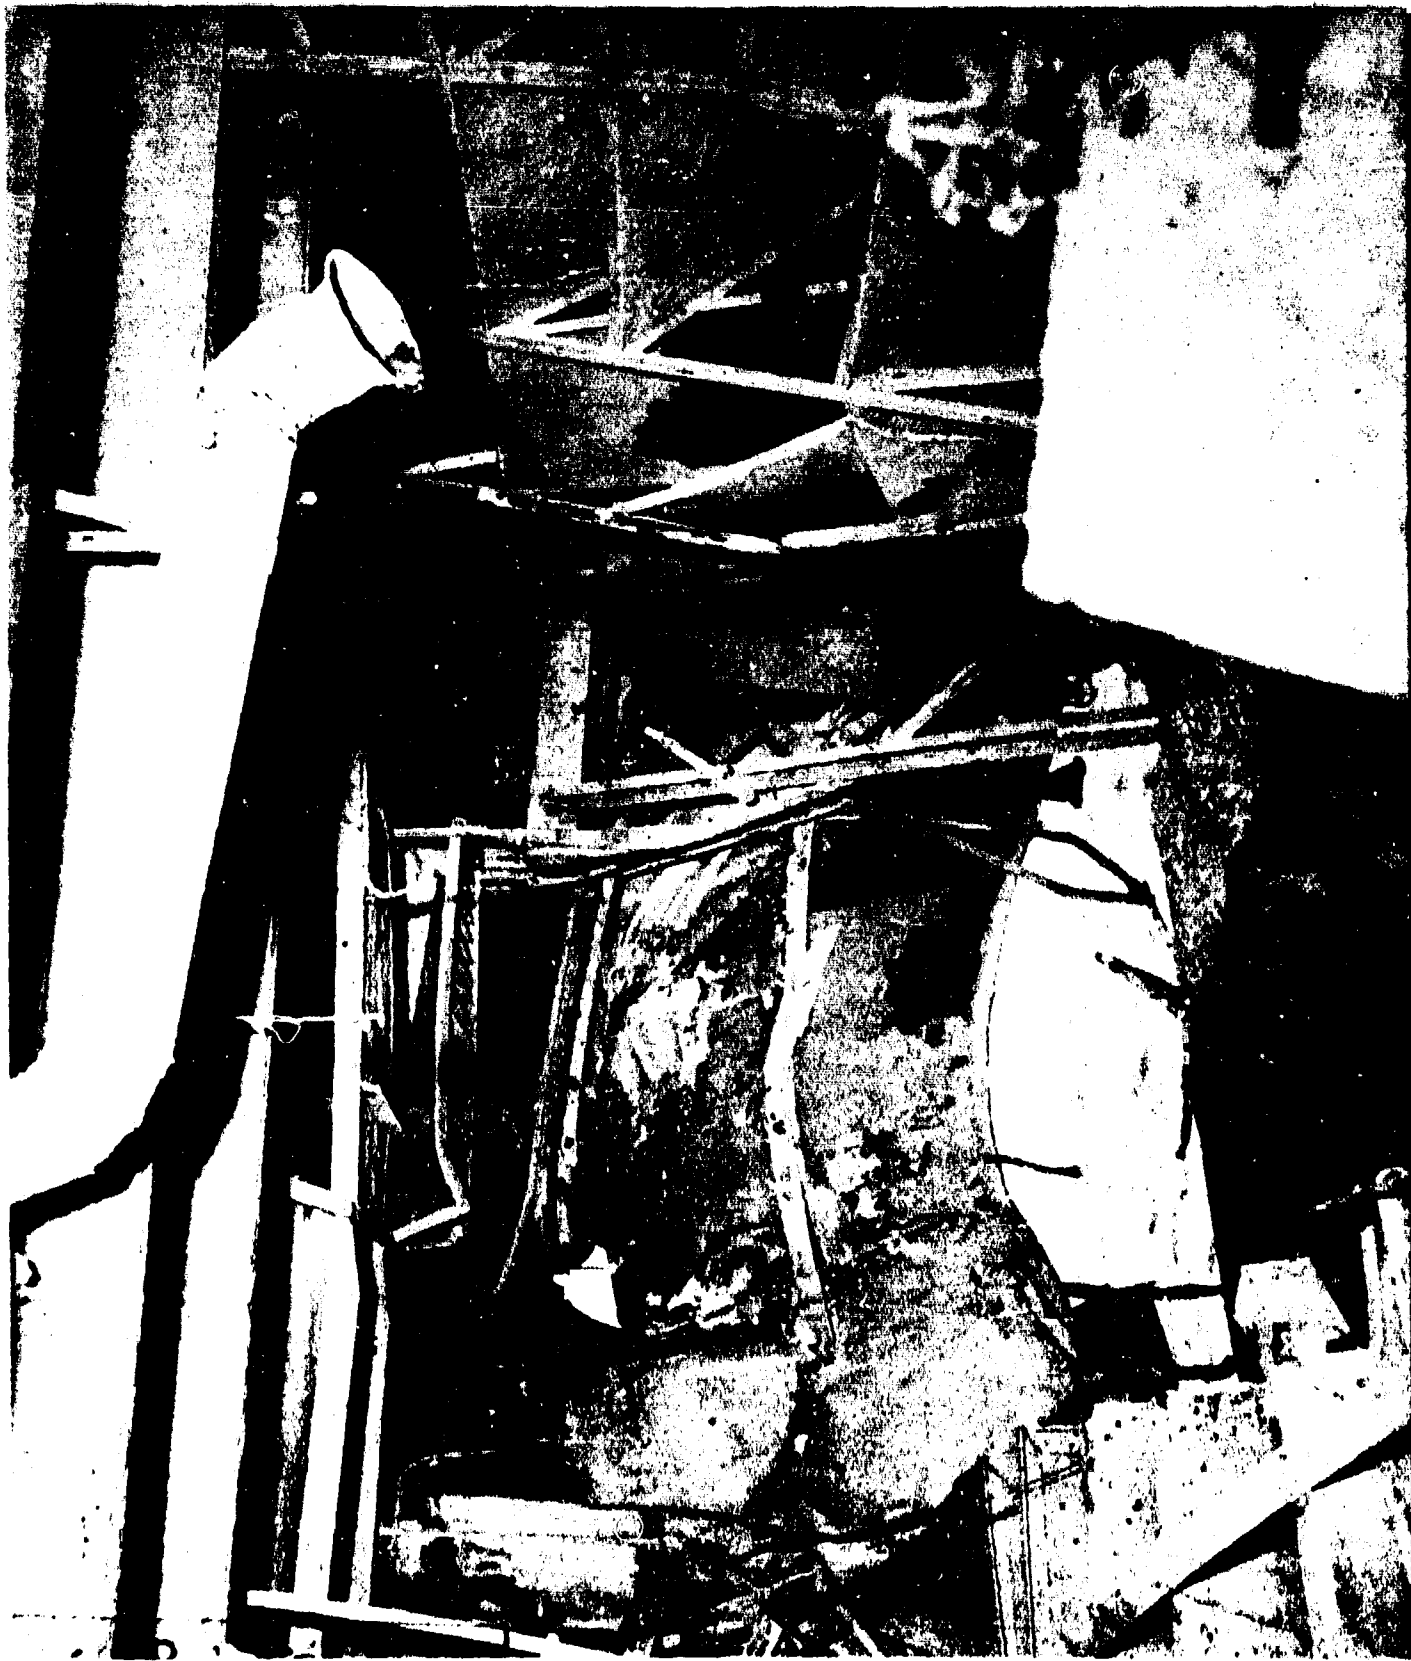
(a) Failure occurred along welded butts and seams in shell plating on the USS INDEPENDENCE as shown in photographs 2216-2, 2216-7, 1733-11, 1734-1, 2114-1, 2117-10 and 2117-11, pages 35, 36, 37, 39, 40, 43 and 44. Certain of these failures occurred in the welds while others occurred in the plate material adjacent to welds. Incomplete weld penetration of the joint caused failure in the former cases, and slight undercut at the edges of the welds contributed to failure in the latter cases. Shell plating in the area of greatest damage varied from 12 to 15 pounds in weight.

Damage to the superstructure on the INDEPENDENCE aft of the hangar space was severe. As shown in photographs 2216-2, 2216-7, 1734-1 and 2114-1, pages 35, 36, 39, and 40 there were numerous failures in side plating which followed welding seams. Certain of the failures occurred in the welds where incomplete joint penetration was observed. Others followed the seams in the plate material adjacent to the welds, and in certain cases appeared to have been caused by slight undercut at the edges of welds.

AA-CR-17-2114-1. USS INDEPENDENCE (CVL22). Failure of side plating along welded seam at level of poop deck. Port side looking outboard.

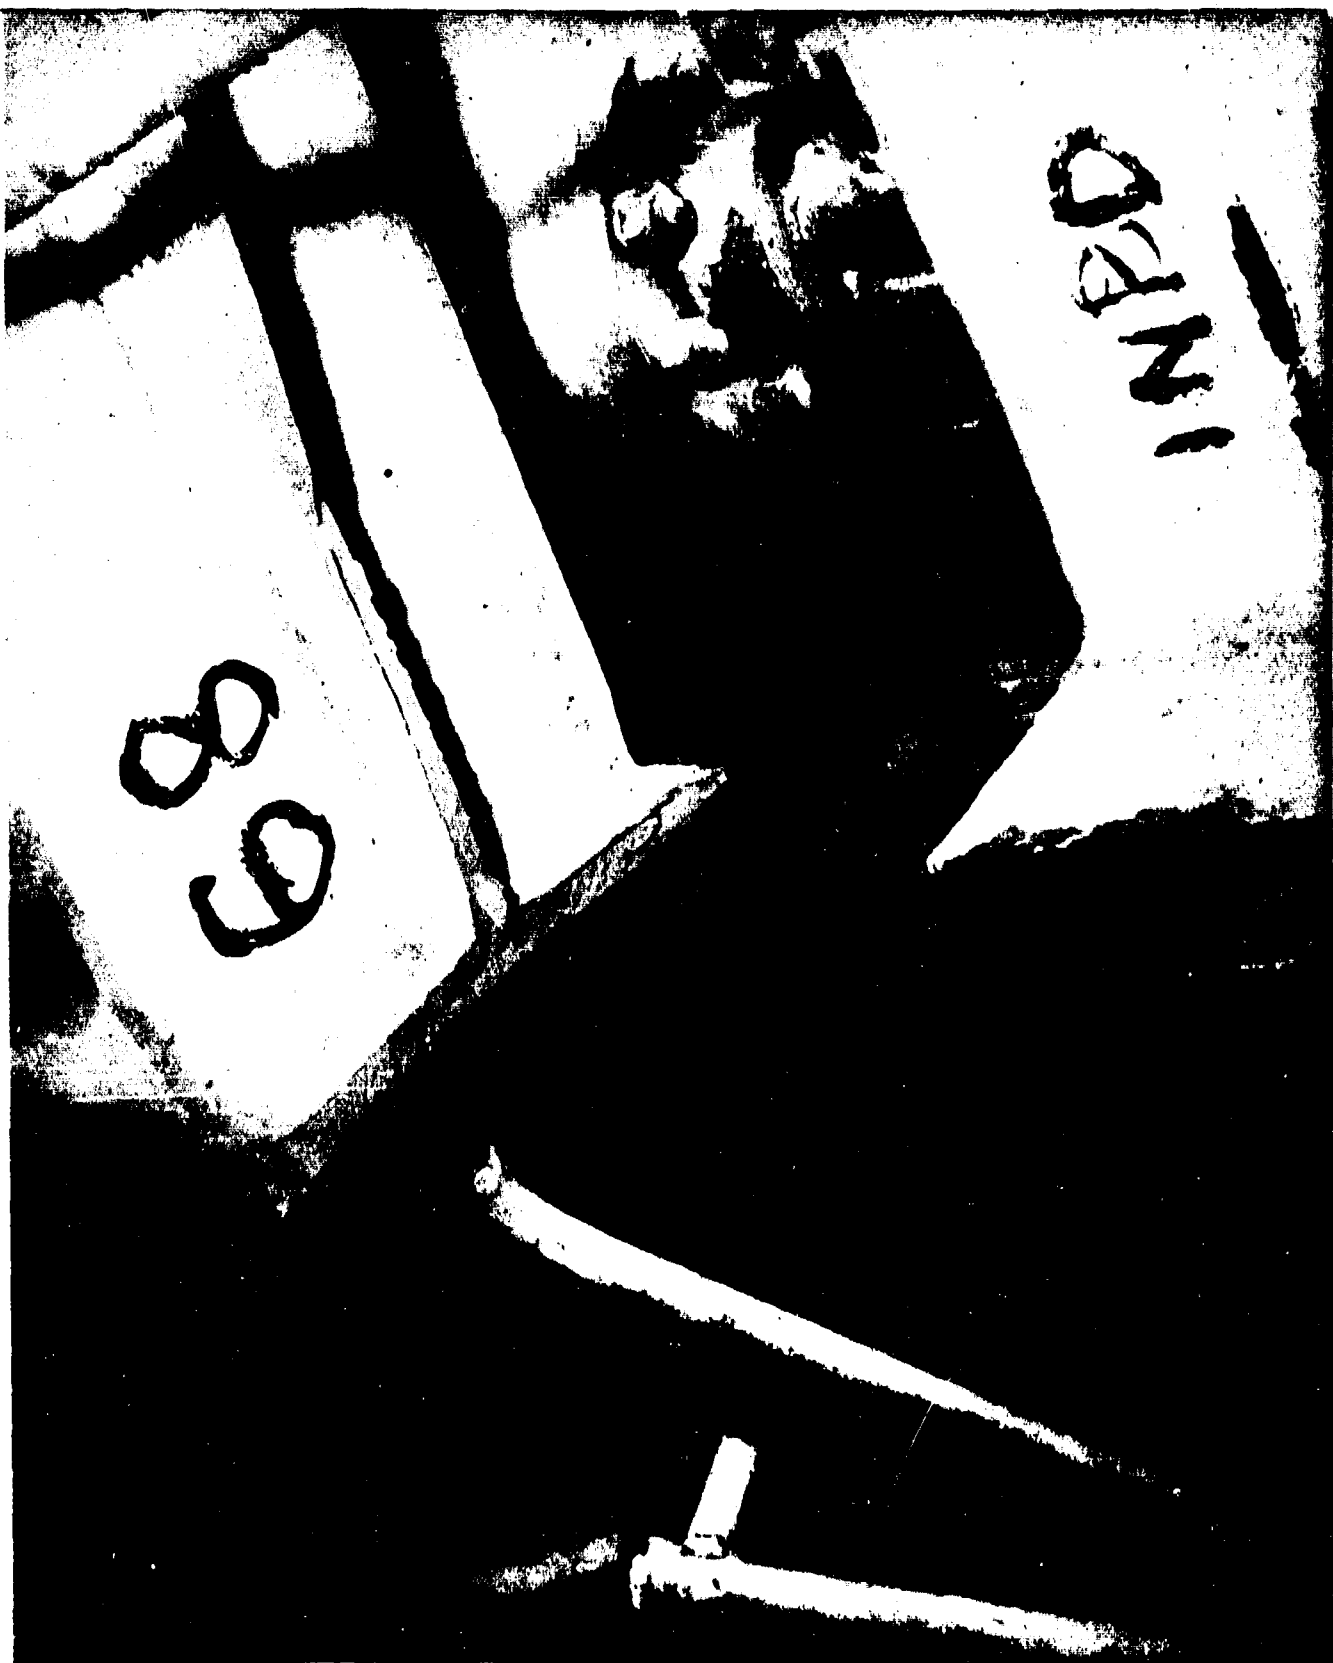
AA-CR-59-4149-5. USS INDEPENDENCE (CVL22). Fracture in flight deck bent column at port overhead bracket. Note herring bone pattern of fracture pointing to origin at toe of fillet weld at left.

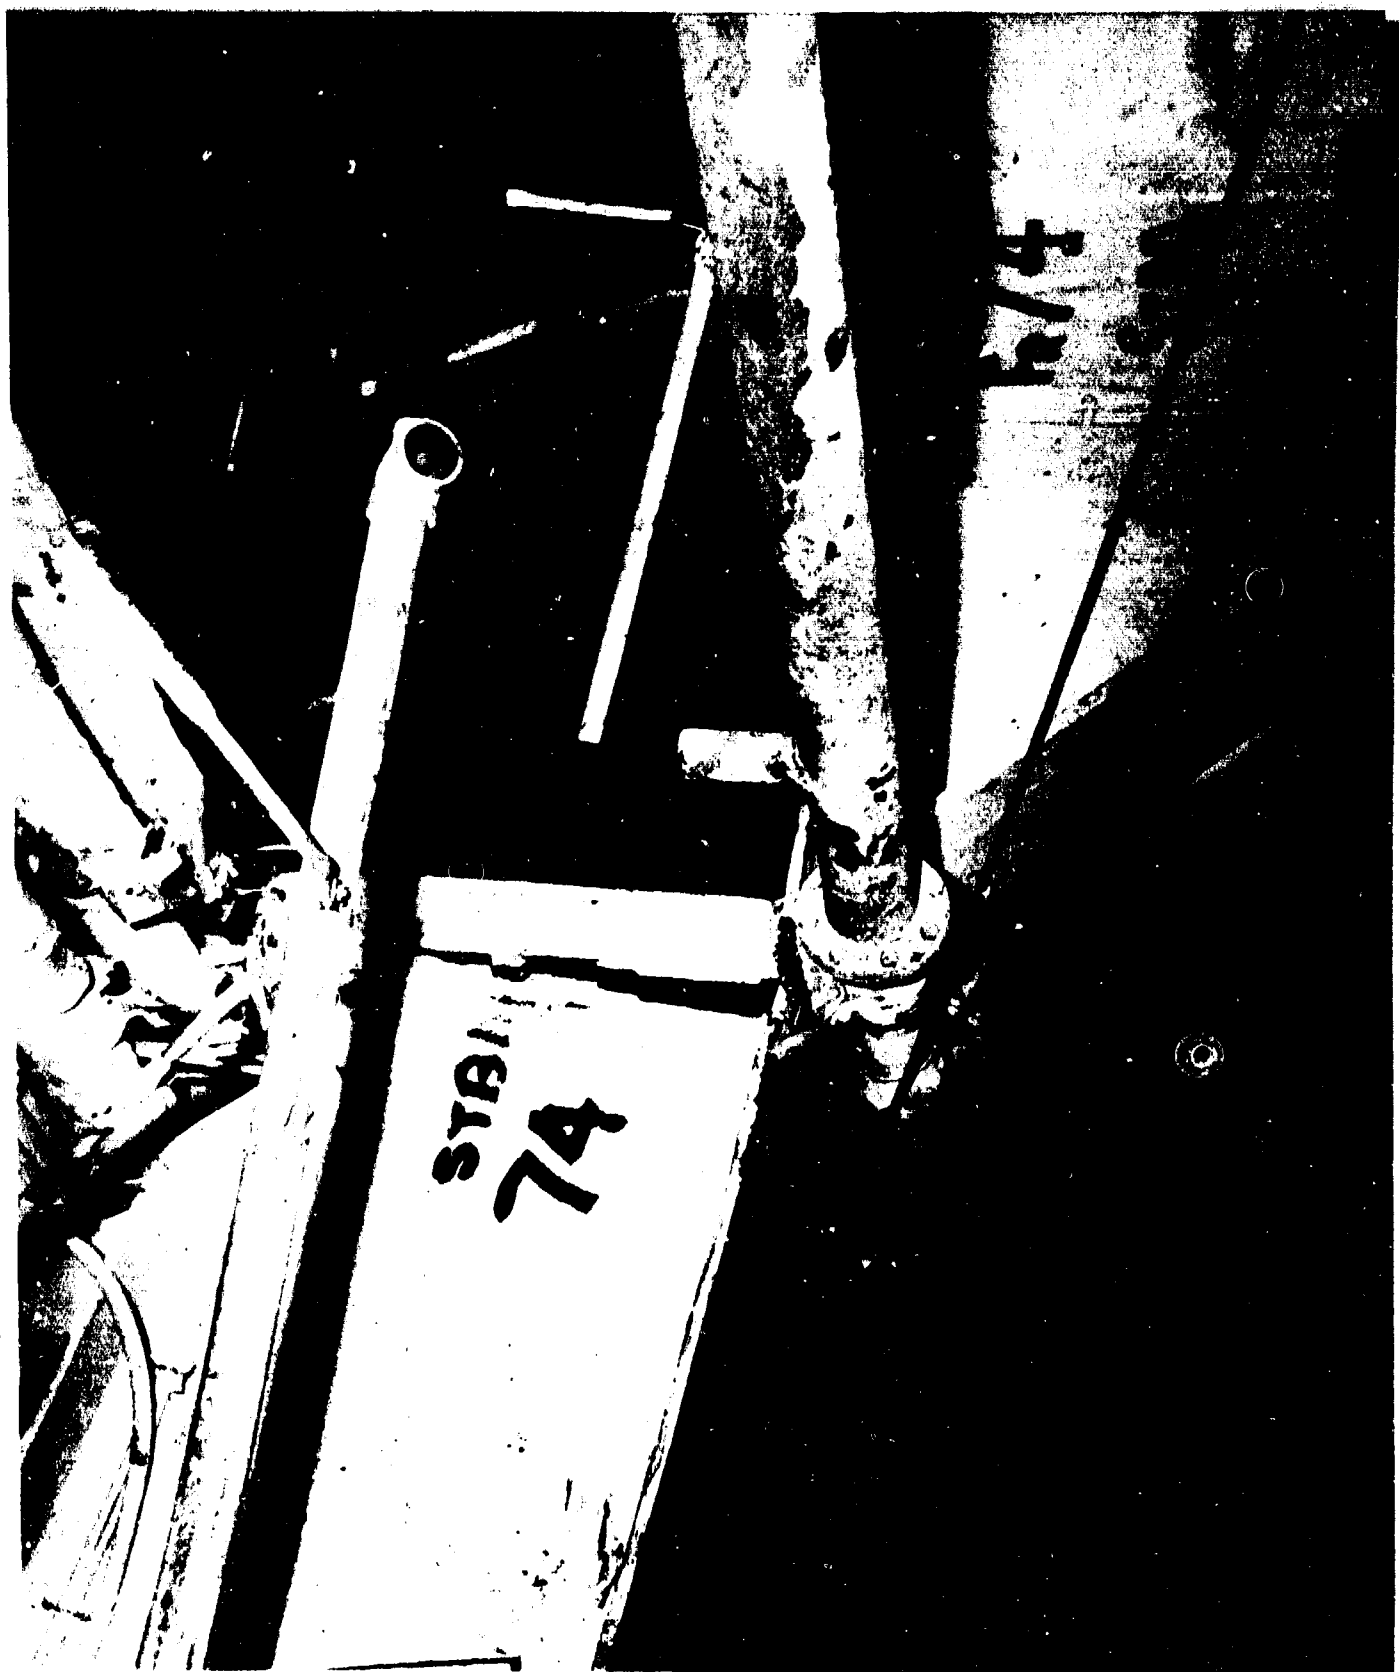
AA-CR-59-4148-11. USS INDEPENDENCE (CVL22). Fracture in flight deck bent overhead connection along inboard edge of vertical weld. Frame 74, looking forward.

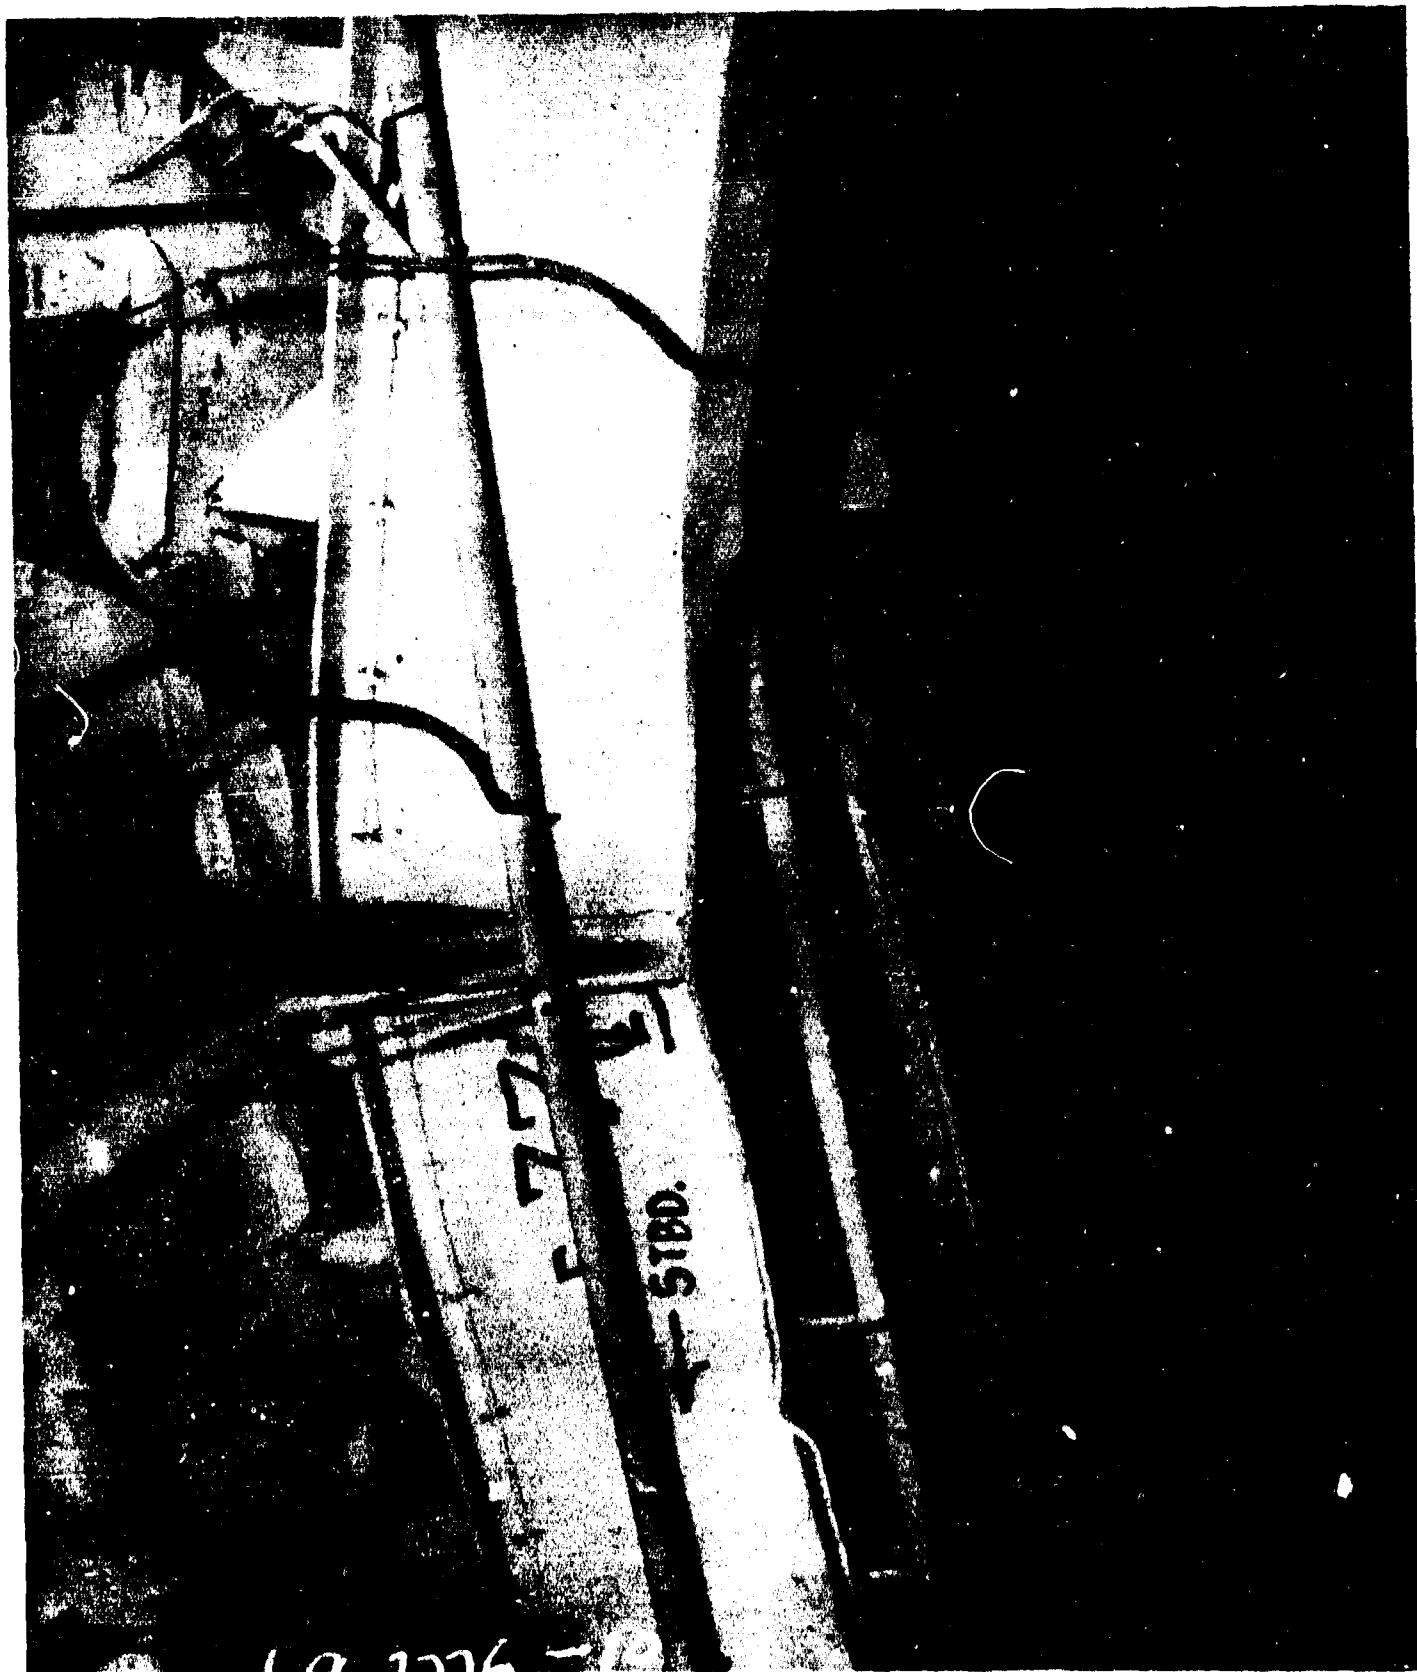
AA-CR-59-2226-10. USS INDEPENDENCE (CVL22). Fracture in center-line butt weld in flight deck bent girder. Fracture originated in weld in upper flange. Looking aft.

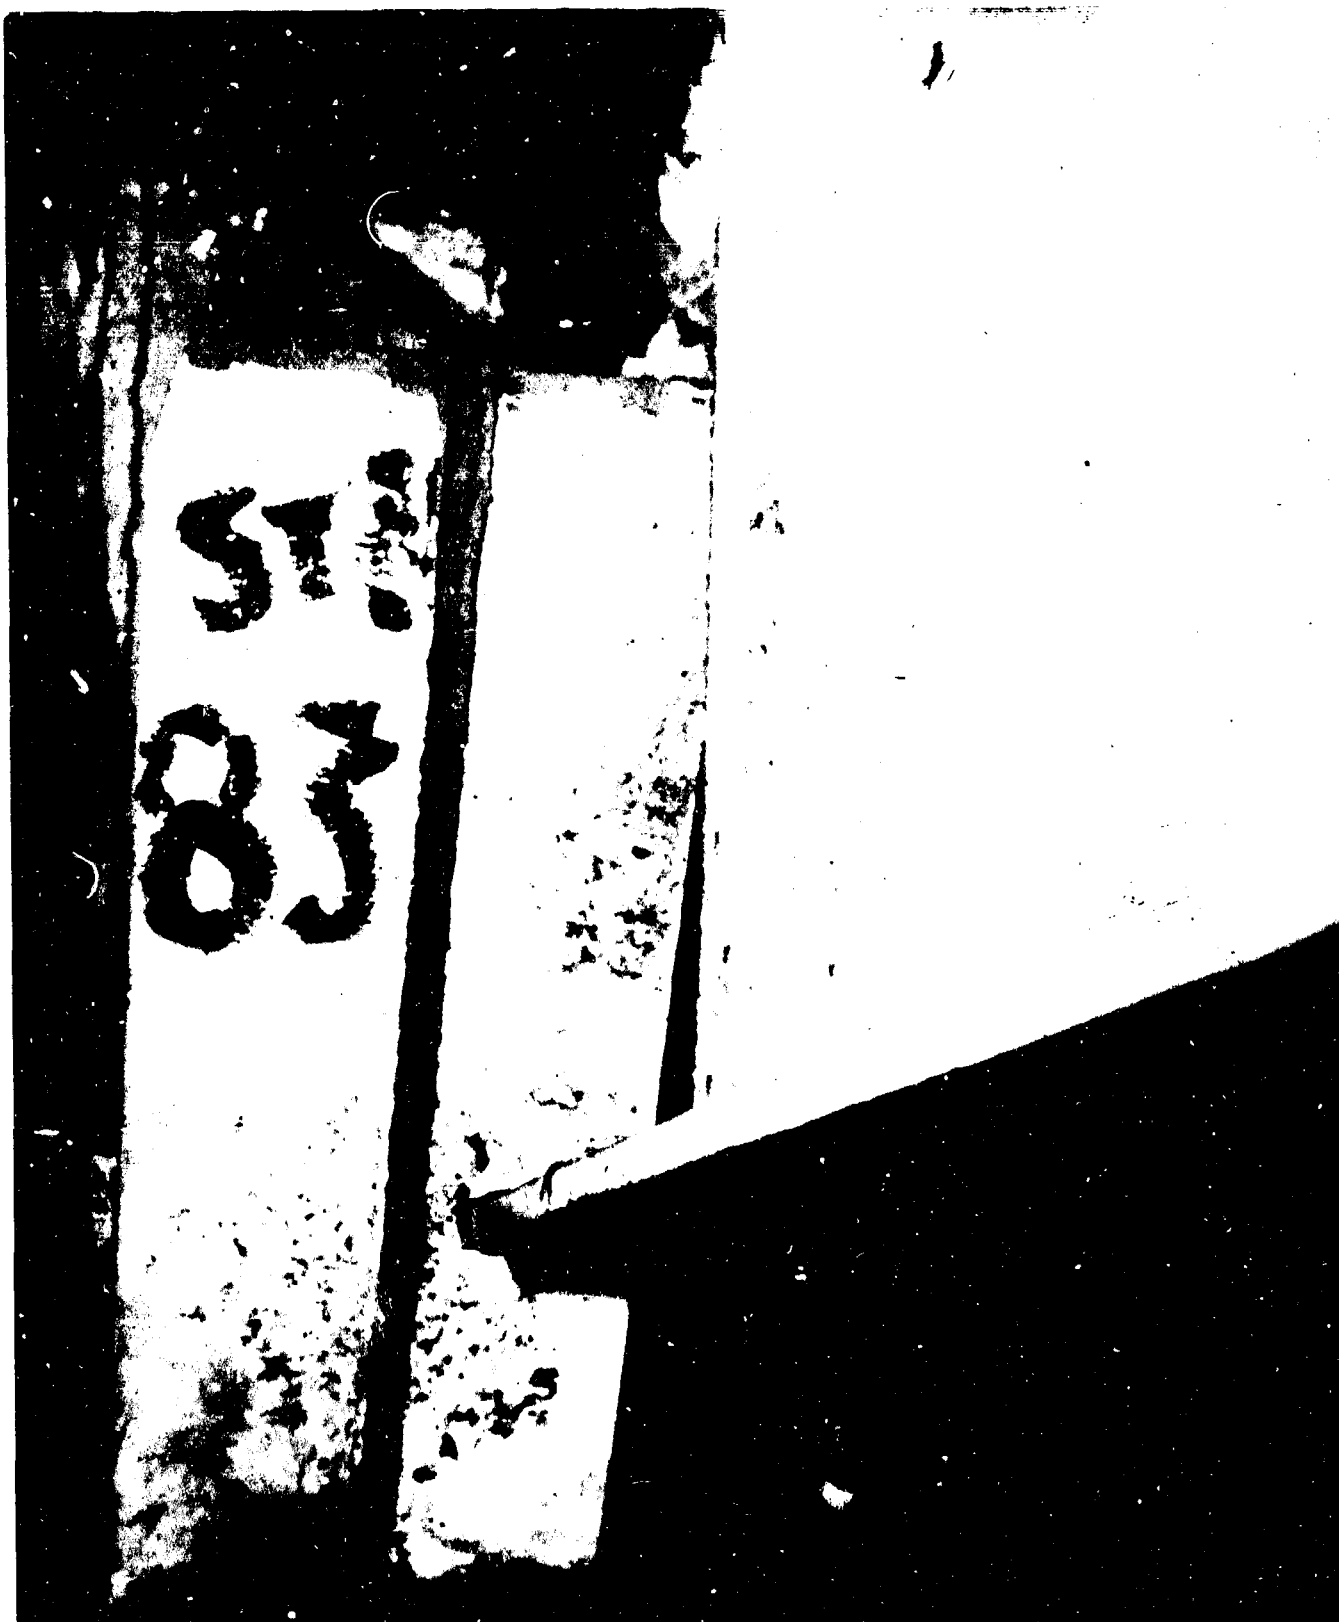
AA-CR-100-4160-10. USS INDEPENDENCE (CVL22). Failure of welds joining flight deck bent girder and bracket to column. Close-up view showing undersize welds and lack of edge preparation. Starboard, frame 83, looking outboard.

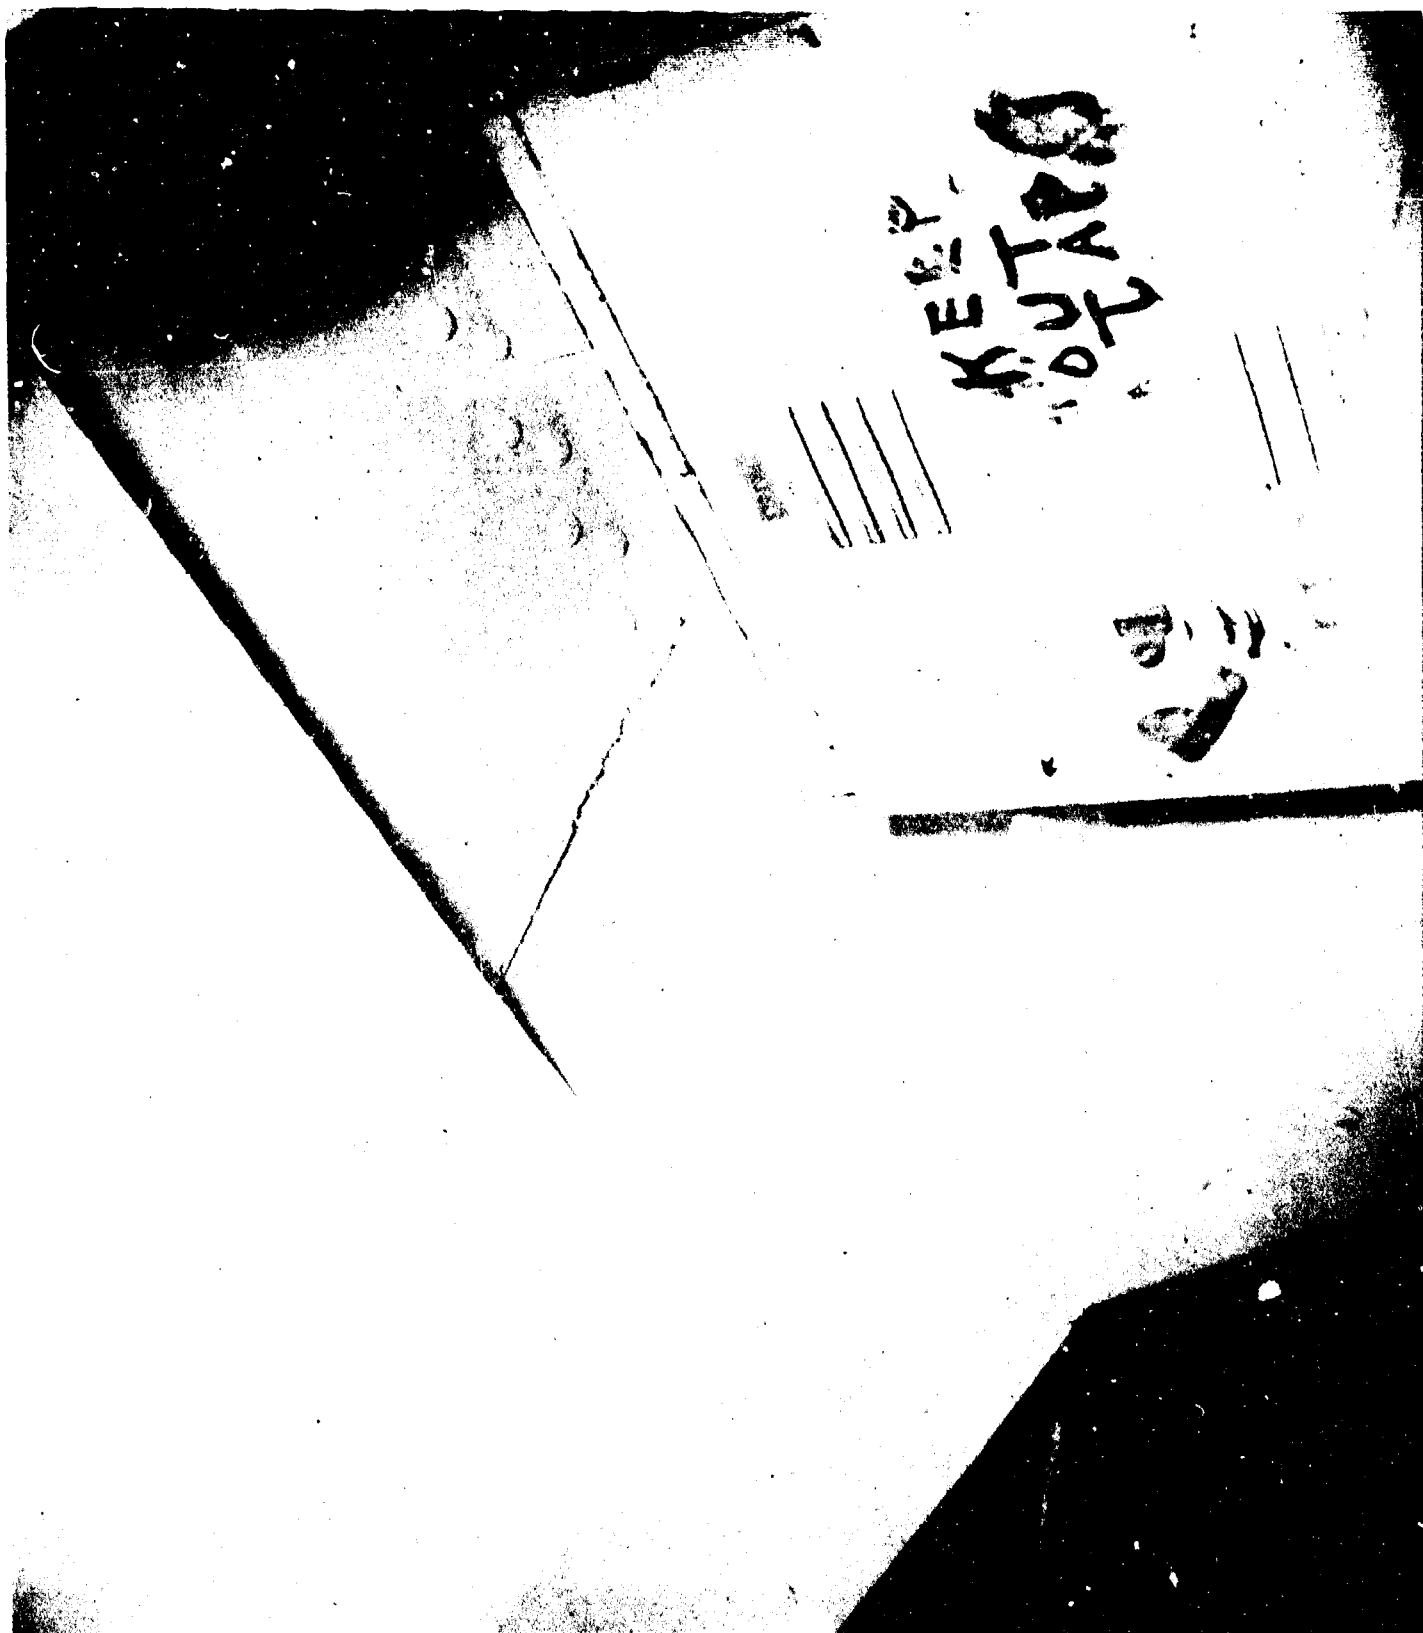
AA-CR-59-2088-7. USS INDEPENDENCE (CVL22). Fracture in web adjacent to weld joining web frame 89, port, to STS stringer strake of main deck. This failure is underneath failure at footing of flight bent 89 shown in photographs 4162-2 and 955-1.

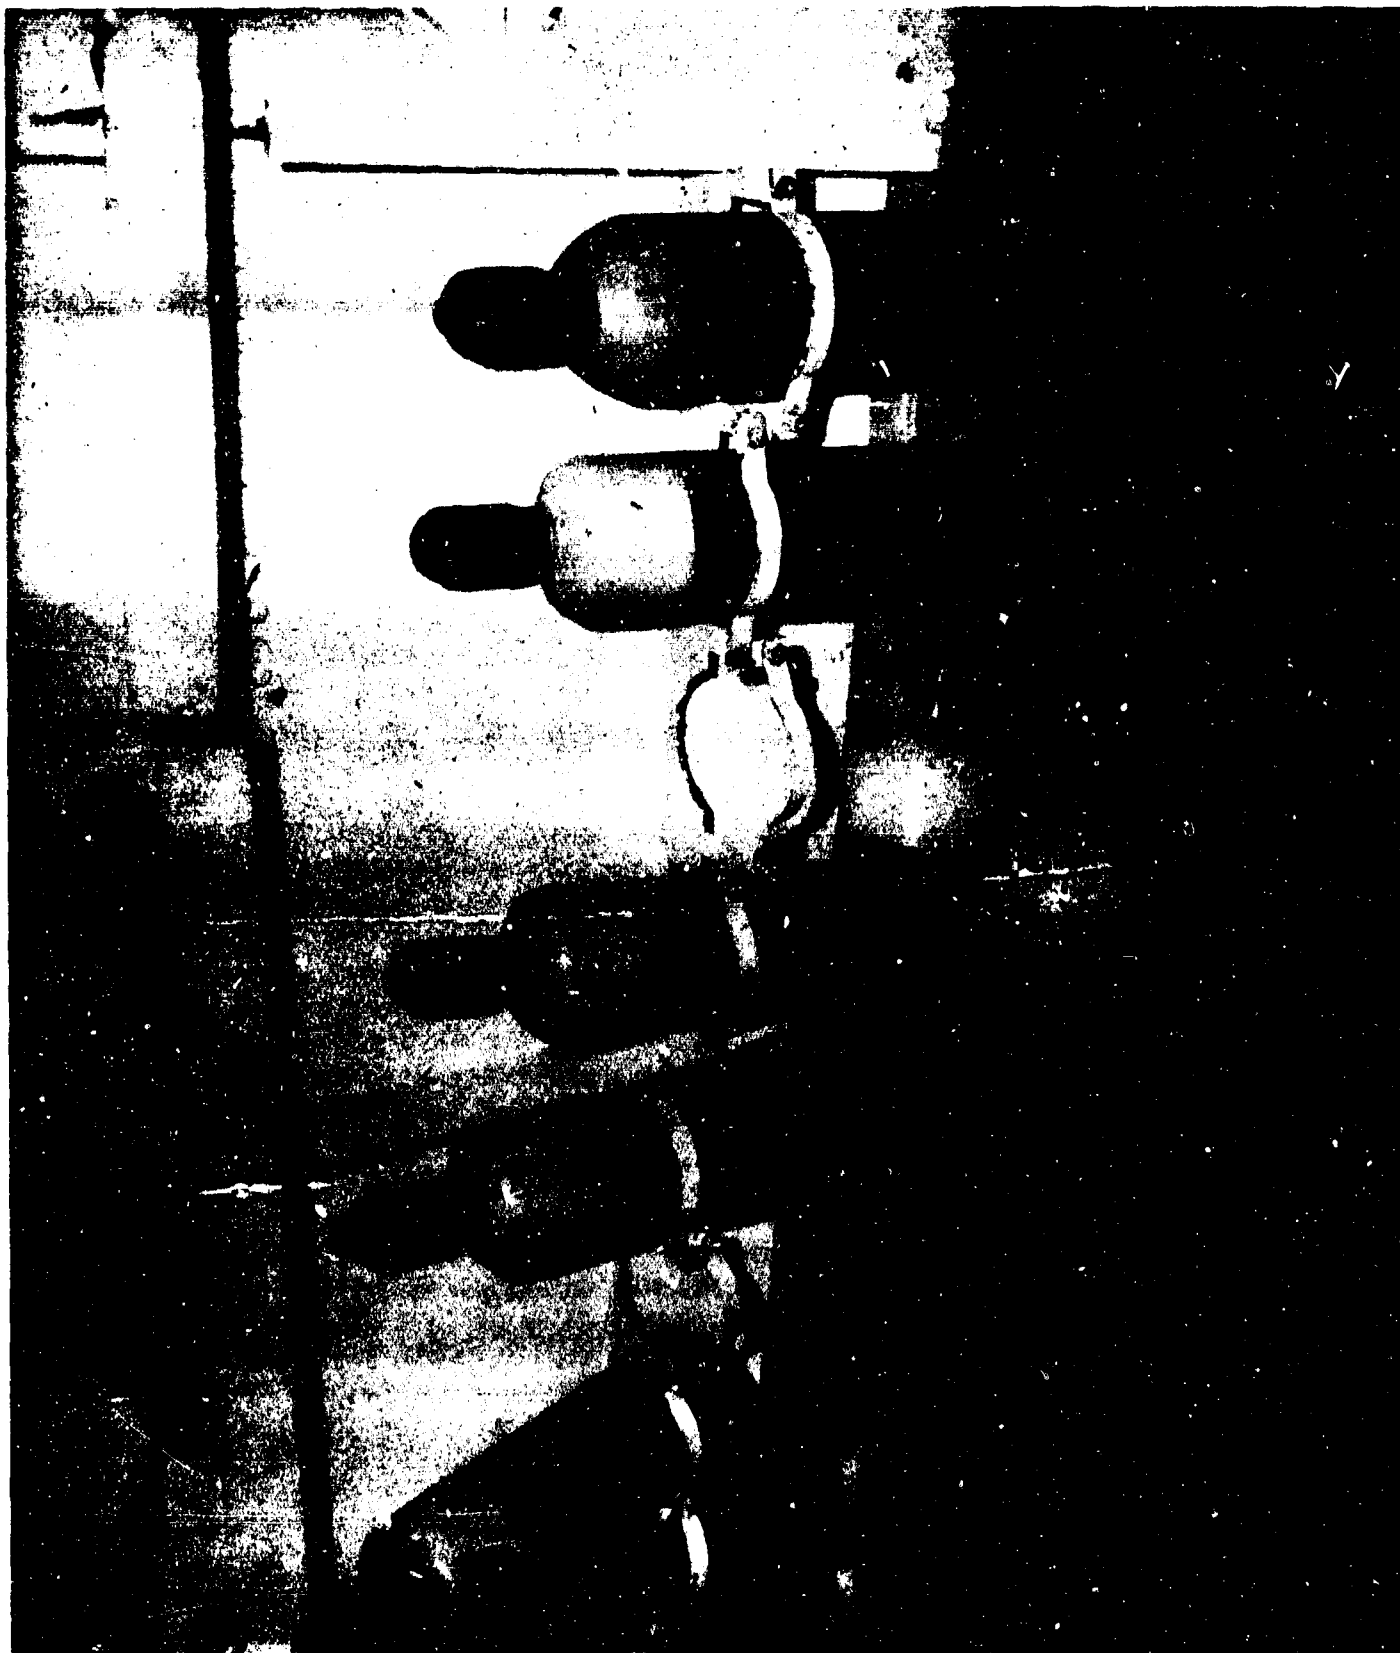
(c) Oxygen, acetylene and other gas cylinders. In most cases gas cylinders were stowed on weather decks. In many instances, such as shown in photographs 1867-2, 1868-3 and 2116-12, pages 22, 23 and 65, cylinders were displaced from stowage racks by the force of air blast against structures to which they were secured. Similar occurrences were observed on Test B target ships moored close to the bomb. Displacement of cylinders in this test was caused by underwater shock. As far as could be ascertained displaced cylinders were undamaged.

Although the main and second decks aft on the INDEPENDENCE were severely deformed on the port side in way of the severely damaged area, as shown in photographs 2216-2, 2216-7, 2071-1, 2116-12, 2041-7 and 2116-7, pages 35, 36, 64, 65, 68 and 70, no failures were observed in welds. Photographs 2040-2 and 2226-12, pages 48 and 50 show deflection of the all welded hangar deck. No failures were found in welds in this deck. In the forward elevator pit on the INDEPENDENCE a failure occurred in a weld in a make up joint in a flush patch in the main deck. Examination of the fracture revealed that the joint edges of the 20 pound plate had not been beveled for welding with a result that very little of the joint was penetrated by the weld. Photograph 2100-4, page 49 shows the fracture which is approximately 6 1/2 feet long. No failures were observed in welds in STS deck plating.

AA-CR-175-2116-12. USS INDEPENDENCE (CVL22). Weld fractures in mid-height stringer and shell frame in way of bulged port shell. Third deck frames 124 and 125. Note displaced gas bottles.

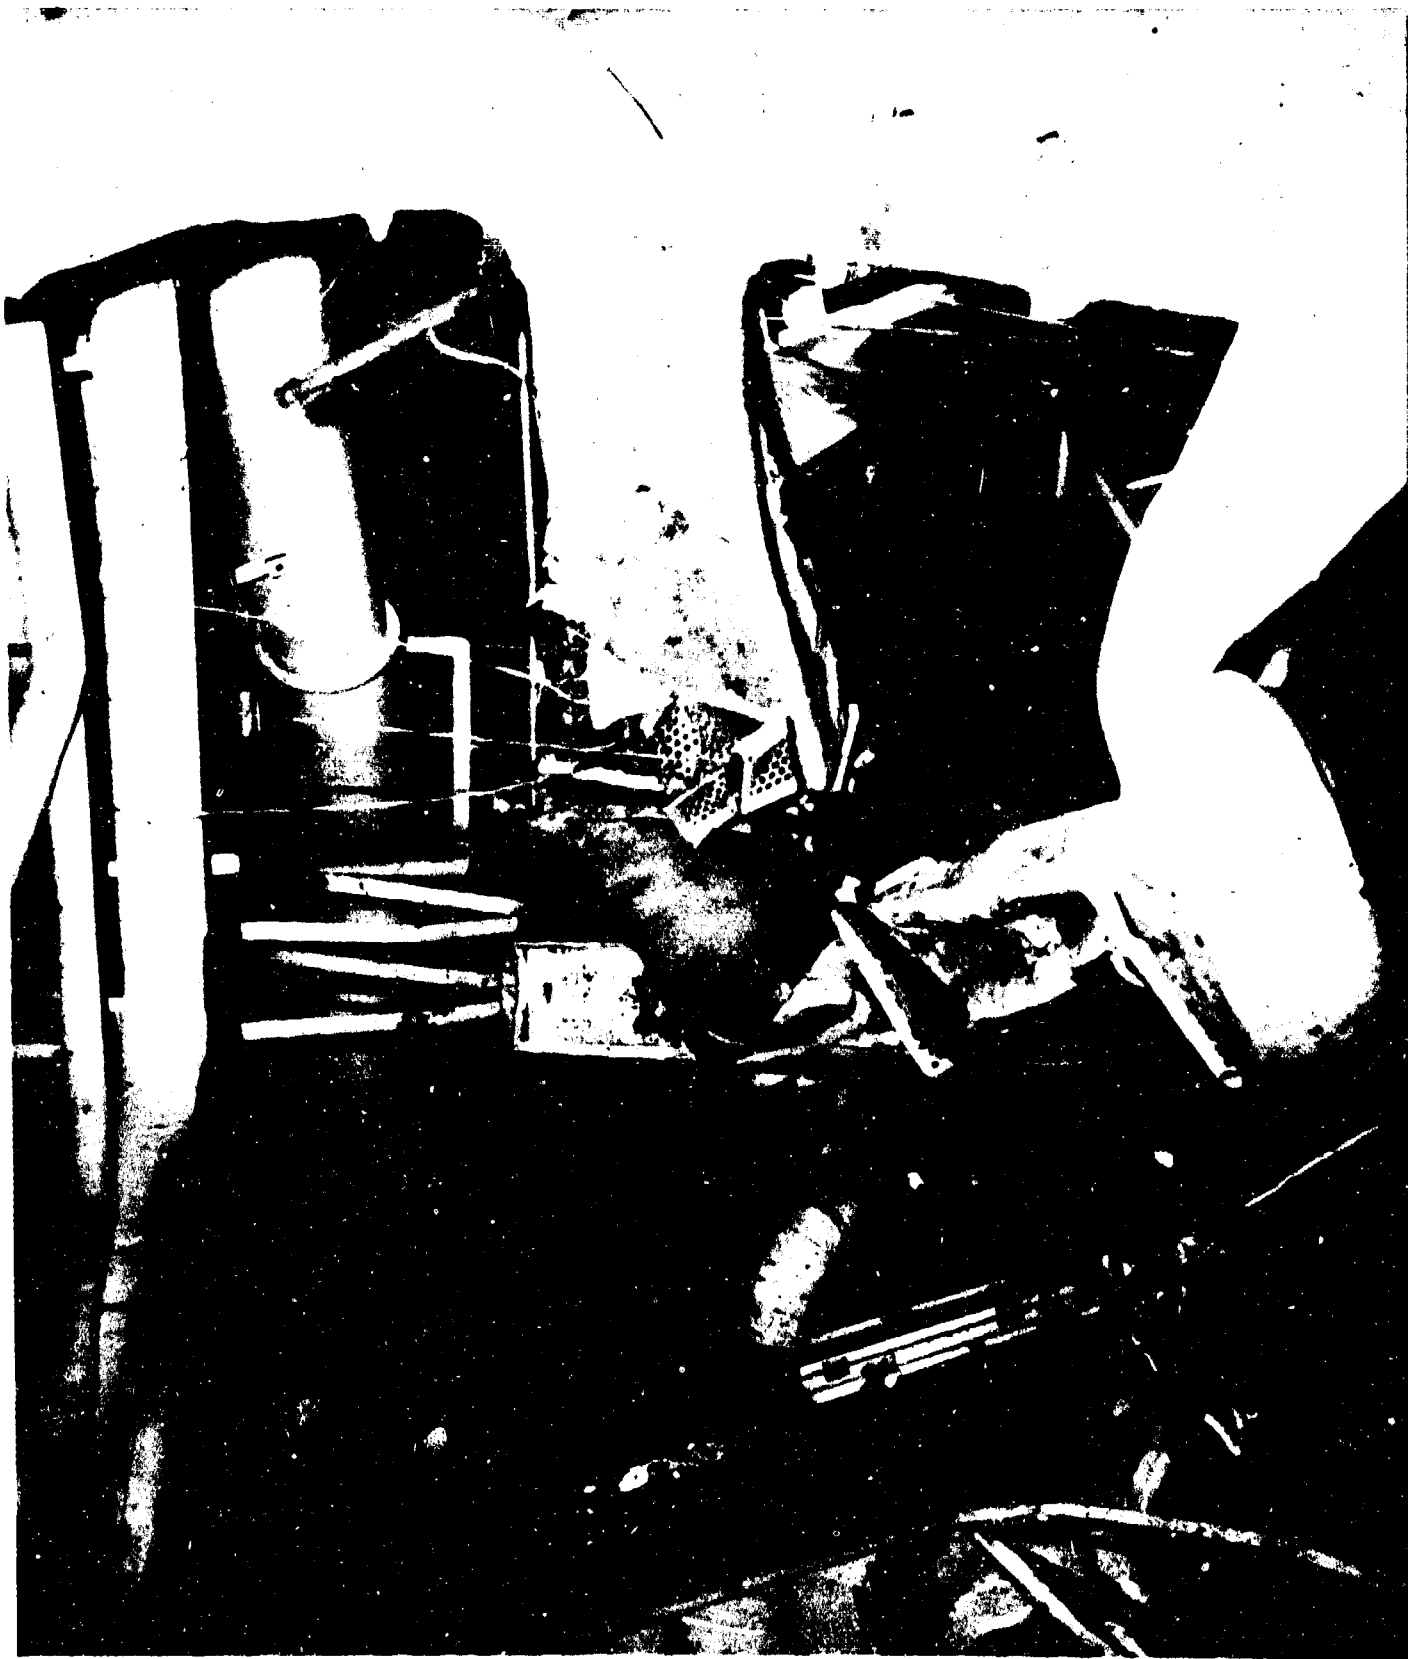
AA-CR-175-2118-2. USS INDEPENDENCE (CVL22). General view of damage to ventilation ducts, second deck port side aft of bulkhead 144.
